THE PRESERVATION OF
ST. PAUL'S CATHEDRAL
& OTHER FAMOUS BUILDINGS

A TEXT BOOK ON THE NEW SCIENCE OF
CONSERVATION, INCLUDING AN
ANALYSIS OF MOVEMENTS IN
HISTORICAL STRUCTURES
PRIOR TO THEIR
FALL

WILLIAM HARVEY

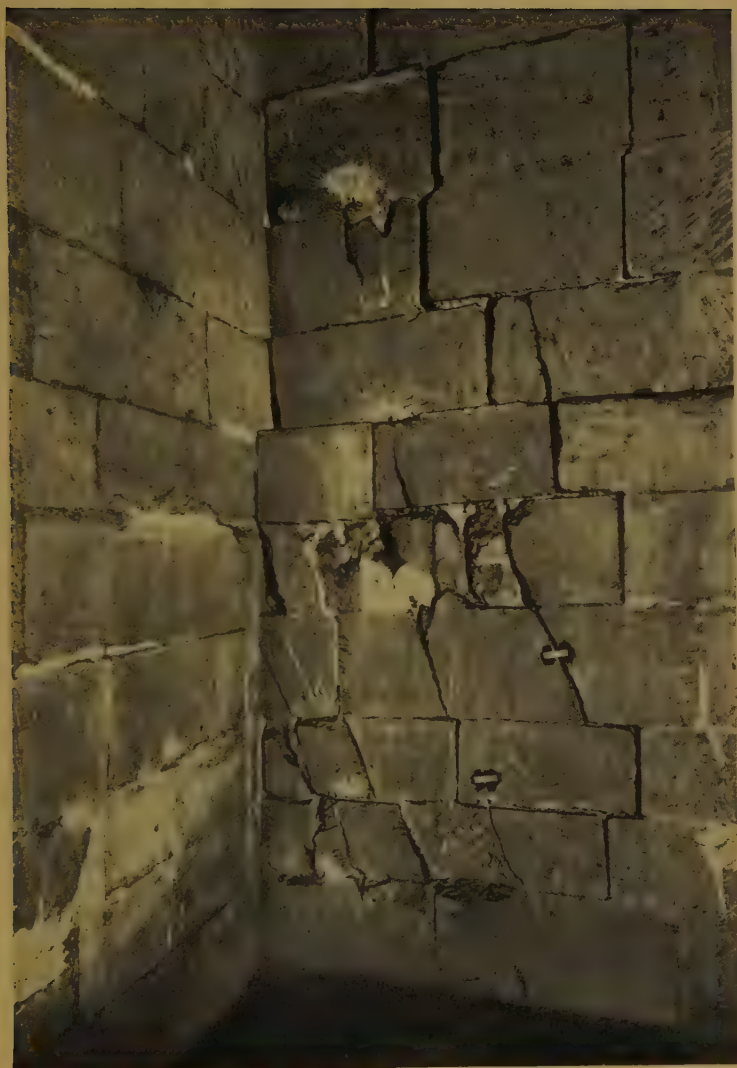
FIG. 4. St. Paul's Cathedral. Cracks in the counterforts or buttresses of the drum .
due to the settlement. These have been filled in. Many years ago it was found that
the dome had sunk and was severed from the surrounding mass.

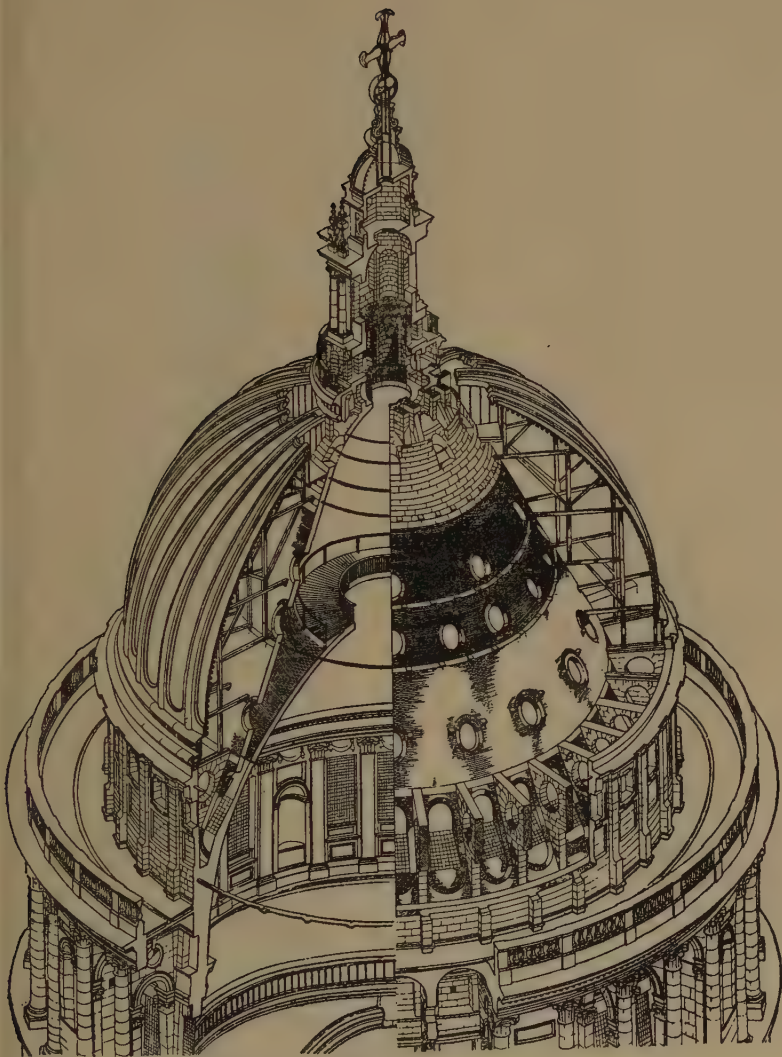
FIG. 10. St. Paul's Cathedral. An isometric view of the dome, showing arrangement of interior structural devices.

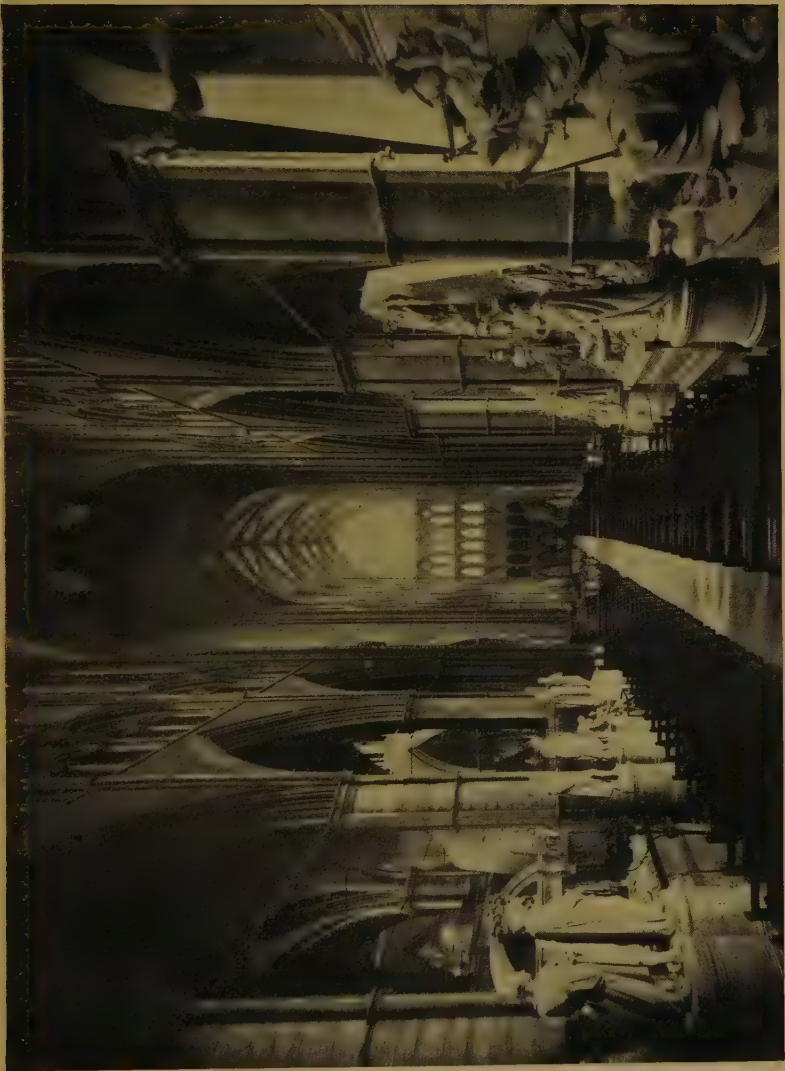
FIG. 15. Westminster Abbey. An interior view showing the structural deflections in the central piers of the tower.
Glance along page from bottom to top to see bends in piers.

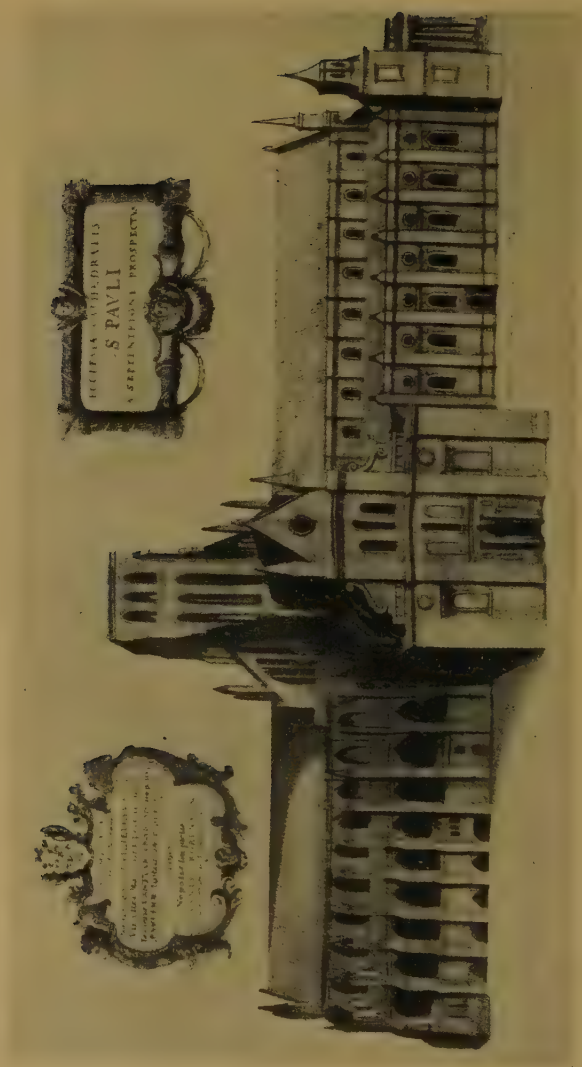
Fig. 16. North elevation of old St. Paul's, as shown in Dugdale's "History," 1648.
Flying buttresses and pinnacles arranged to direct thrusts downwards.

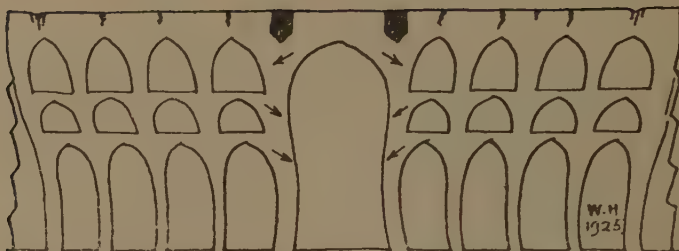
FIG. 17. Exaggerated sketch showing a Gothic arcaded building in decay. An arcaded building bends in every part before absolutely falling to the ground. The curves occur in response to the adaptation of the material to its conditions of shaping and loading, but have been mistaken for purposeful artistic refinements by some observers.

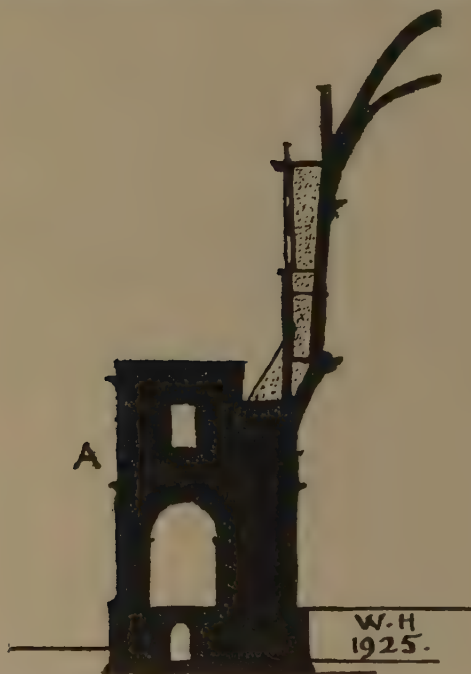
FIG. 18. Section through transept of St. Paul's on line of great pier. The buttressing action of the face wall A of the transept is very slight and is showing signs of failure.

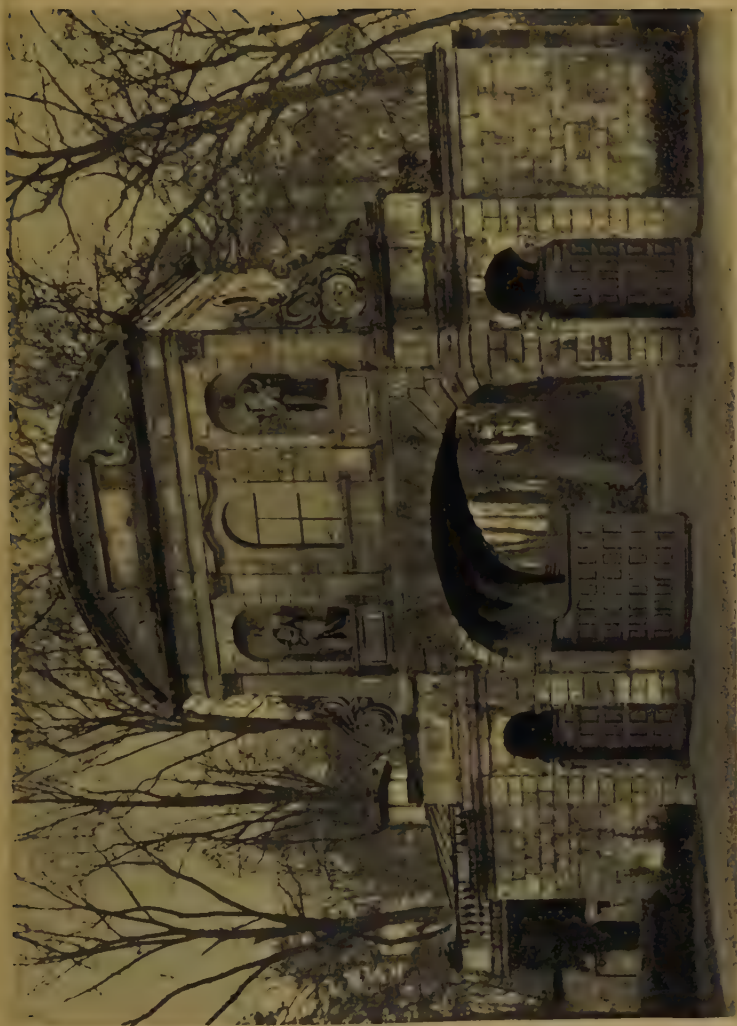
FIG. 19. Temple Bar. Showing Wren's use of horizontal abutments to arch pressures. Compare with Gothic flying buttress form of arch and pinnacles on FIG. 16.

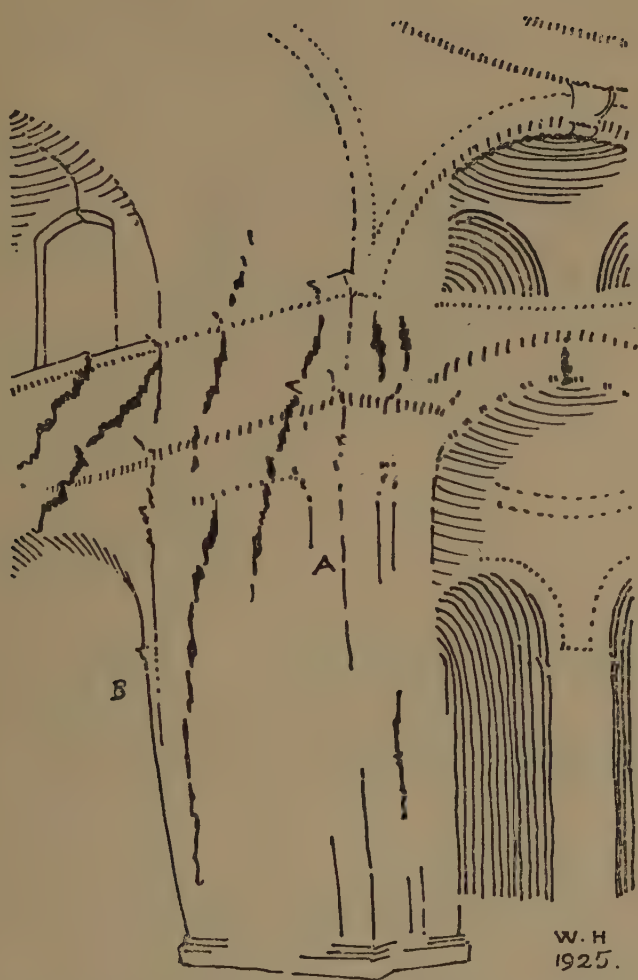
FIG. 22. Exaggerated view of bends and cracks such as might be expected to develop in piers loaded like the eight main piers of St. Paul's dome. A=corner of pier overturning into high nave. B=corner overturning away from centre of dome. The danger of corner A failing as a separate mass is very grave. These twists and bends of the piers are not even mentioned in the Commission's Final Report, and are ignored in its optimistic estimate of the building's stability.

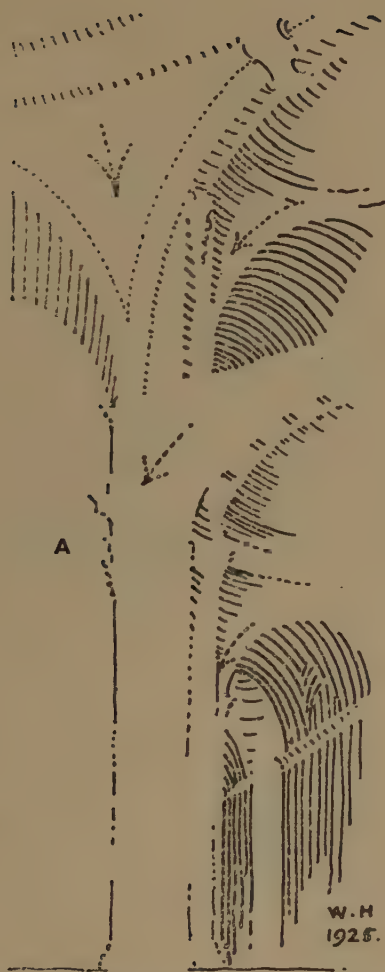
FIG. 27. The eight main piers of St. Paul's Cathedral are being twisted, bent, and overturned as well as crushed by the excessive load. They are splitting in response to highly complex cross-thrusts, some of which are becoming more dangerous with the partial, but increasing, failure of the buttressing system. The piers bulge inwards at A in response to the kick and settlement of the diagonal great arches which receive more and more load as the bastions receive less and less through decay in the semi-domes and counterforts.

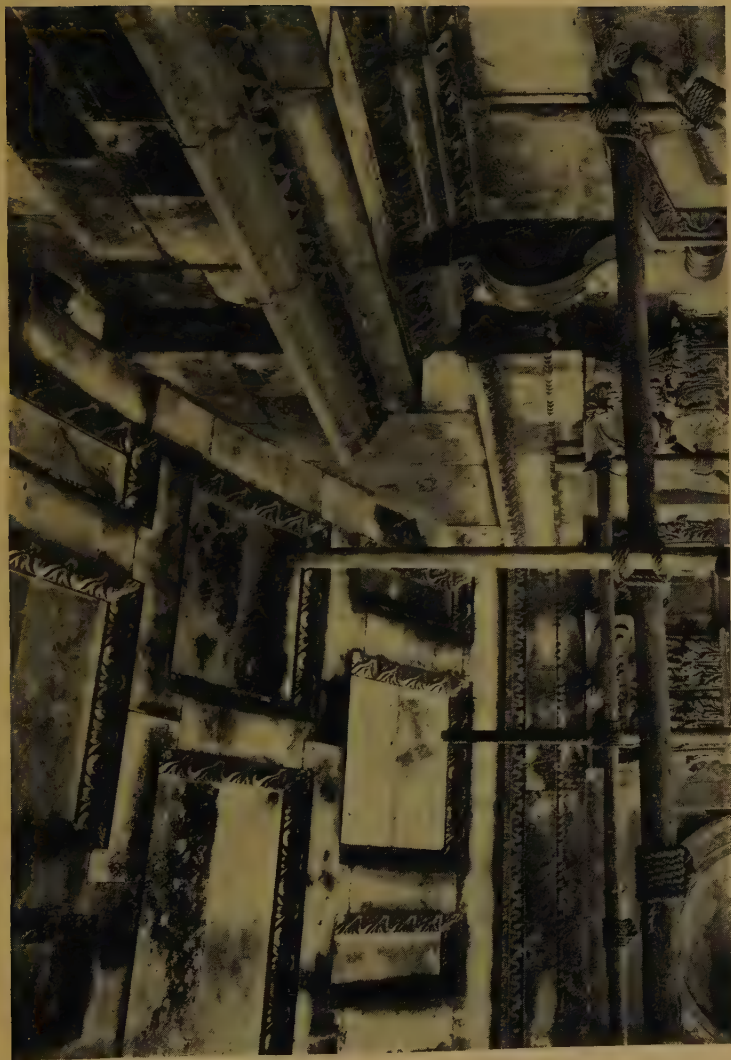
FIG. 28. St. Paul's Cathedral. Drooping and fractured masonry at the west end.

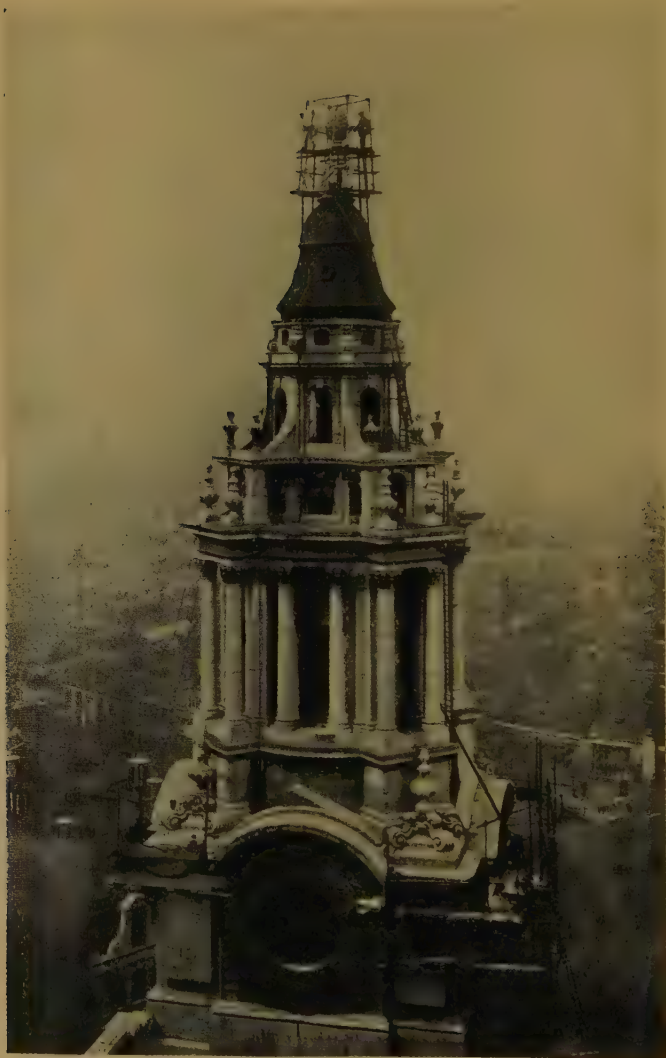
FIG. 29. The South-West Tower of St. Paul's. Years ago the tower was reported out of perpendicular, but this fact was not associated with the general drift of the arches and buttresses throughout the building towards a point of weakness. See also figs. 17, 18, 55, 64, 65, and 70.

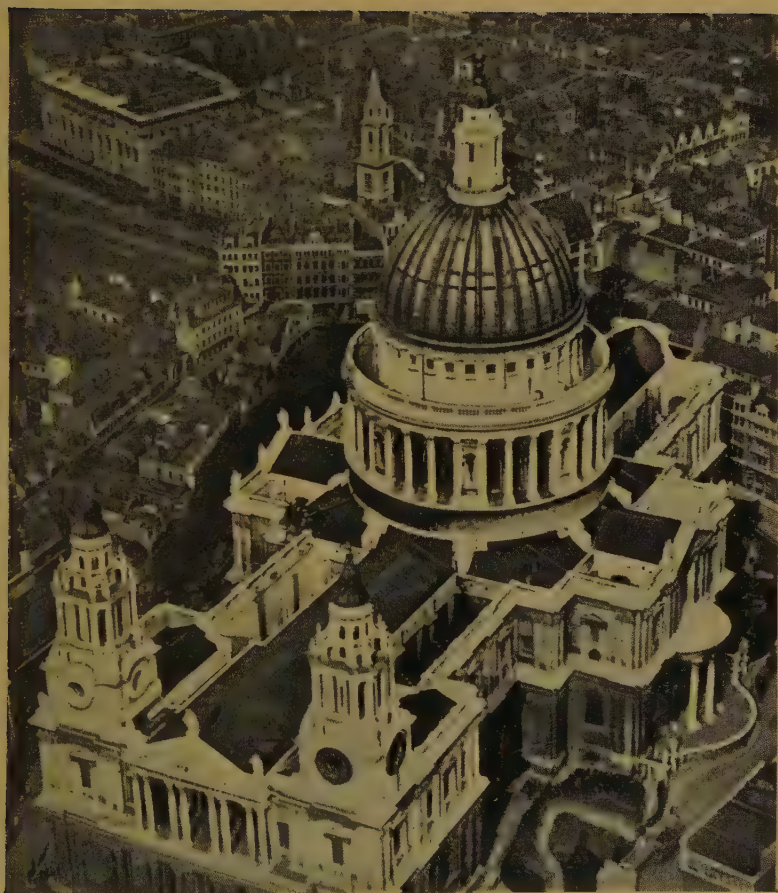
FIG. 34. This view of St. Paul's is interesting as showing how the drum bearing the great dome is in turn supported on its eight piers. The view also reveals the true walls of the nave, transepts, and chancel behind the screen walls which alone are seen from the street.

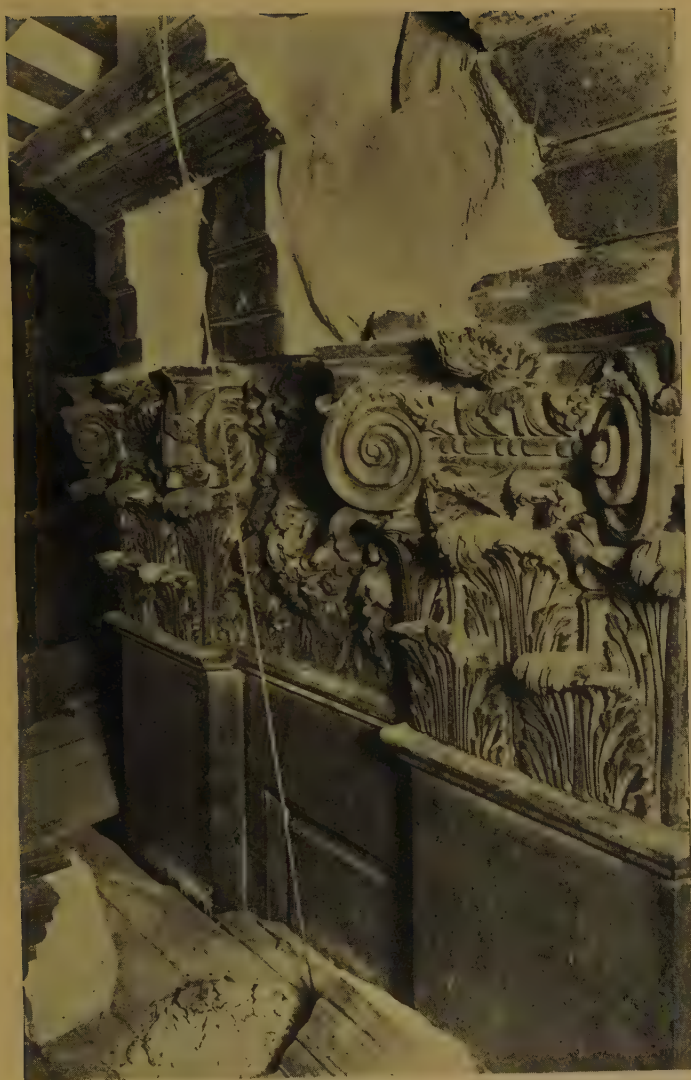
FIG. 36. The fractured frieze of one of the piers at St. Paul's.

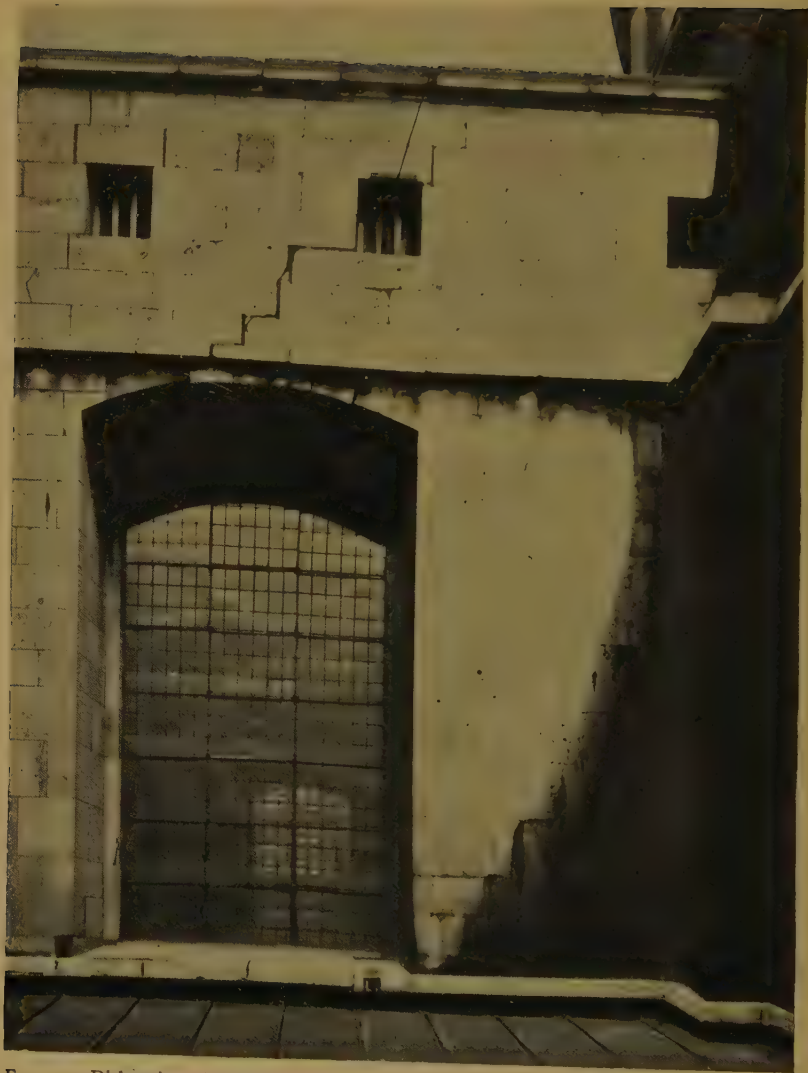
FIG. 37. Dislocation of masonry at St. Paul's Cathedral. Right-hand side is dragged down by the weight of the dome. Compare condition of masonry with the statement in the Commission's Final Report on page 128.

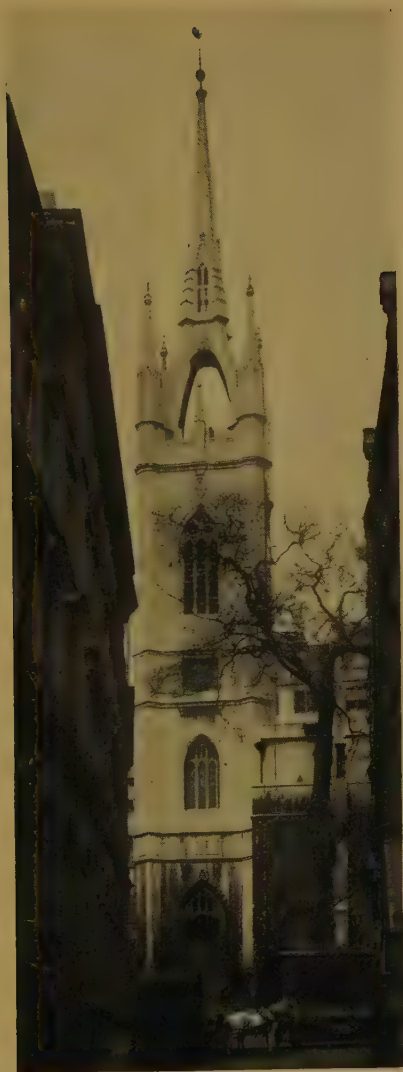
FIG. 44. The steeple of St. Dunstan's-in-the-East. Illustrating a method used by Wren of distributing weight by inclined supports. He omitted to adopt this method in connection with the arches buttressing the eight main piers of St. Paul's, but attempted to employ it in the upper semi-domes at the four corners of the central part of the building.

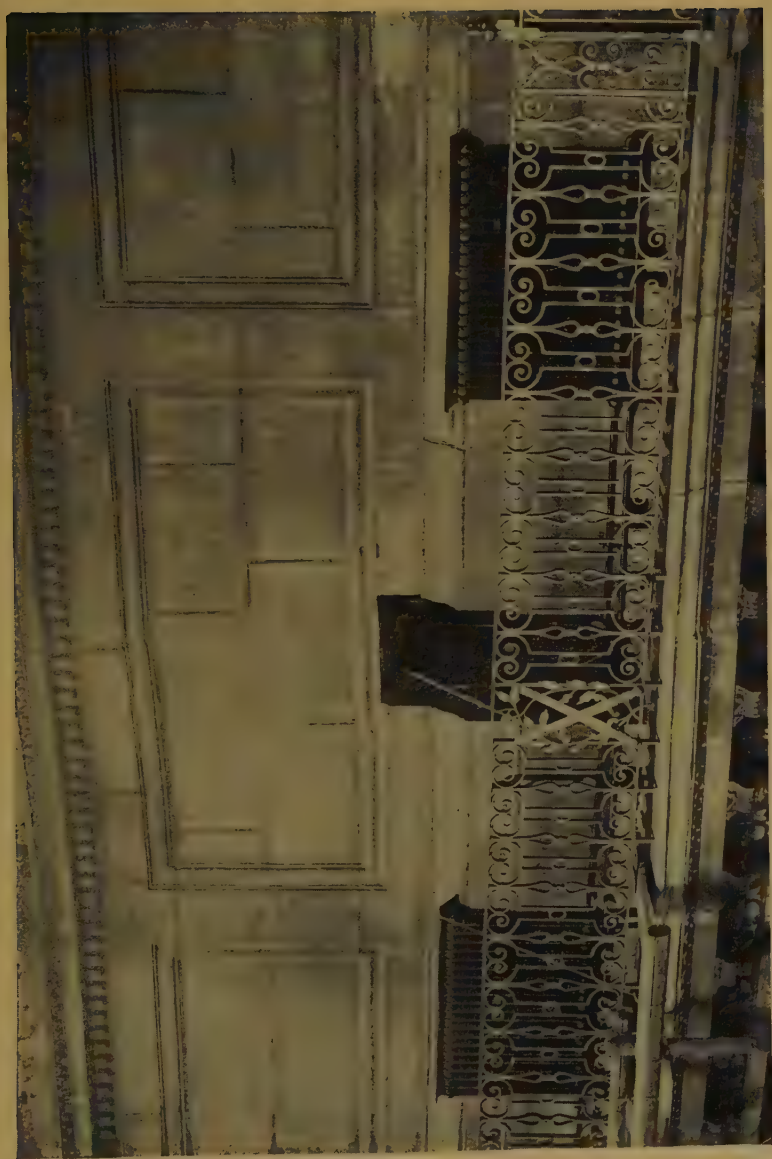
FIG. 47. A view showing settlement at the level of the main interior cornice, St. Paul's. The dislocation is seen when viewed from one side.

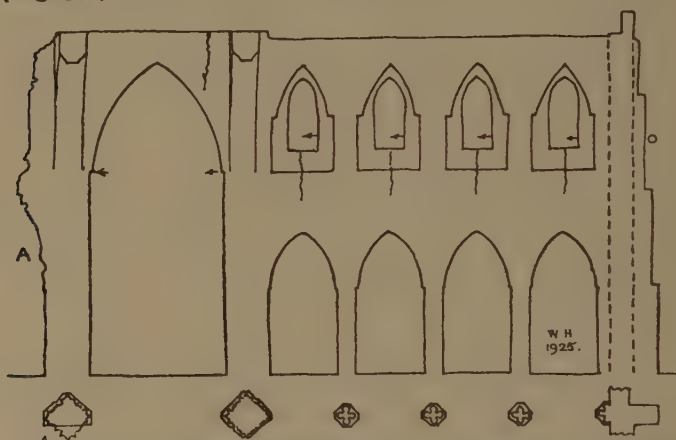
FIG. 55. Tintern Abbey. Outline of north chancel wall. The buttress at the east end stands practically upright, but each pier leans towards the west, drawn over by the failure of the north-west pier of the crossing A, which has been left unbuttressed by the fall of the north high wall of the nave.

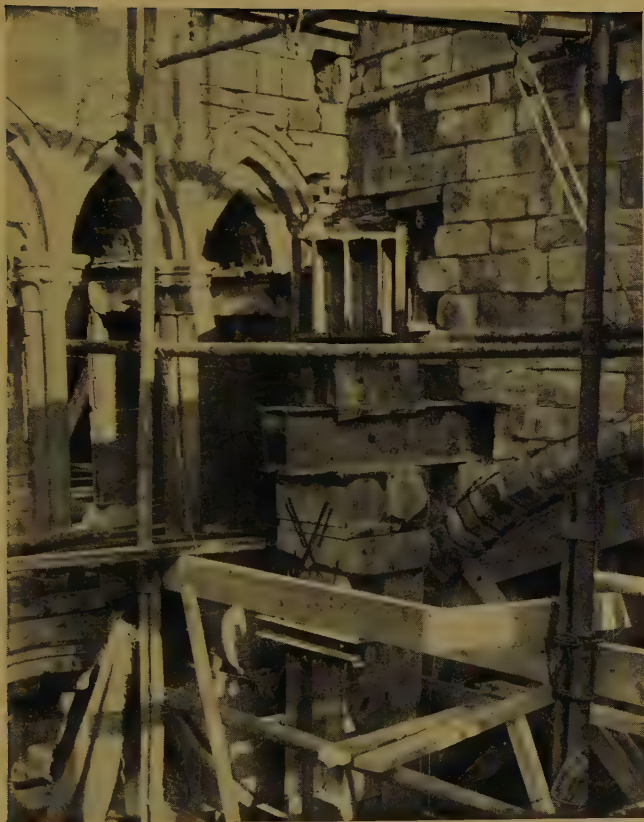
FIG. 56. Repairs to Jedburgh Abbey Church. Steel needles inserted in the old masonry to carry its weight during re-coring operations to the piers undertaken by H.M. Office of Works.

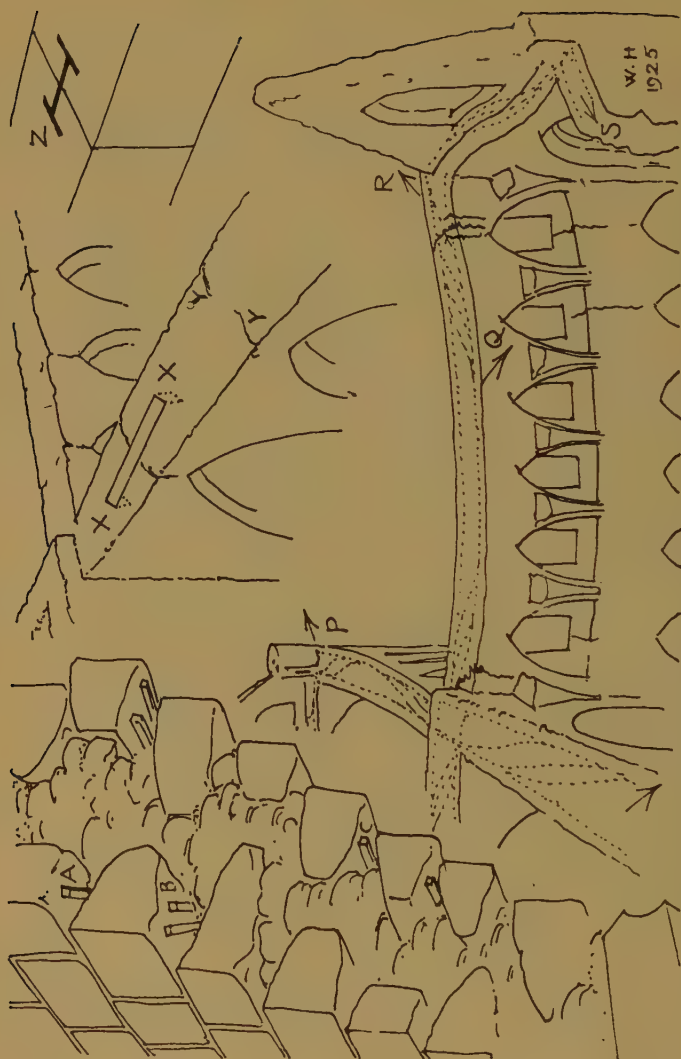
FIG. 57. Metal cramps Z were used in the construction of ancient buildings to hold the blocks of marble together. Rods A B C have been used in repairs to hold up stones in detail. Cramp X X would not prevent movements at Y Y. Movements P Q R S can only be restrained by thoroughly systematic reinforcement of the whole building.

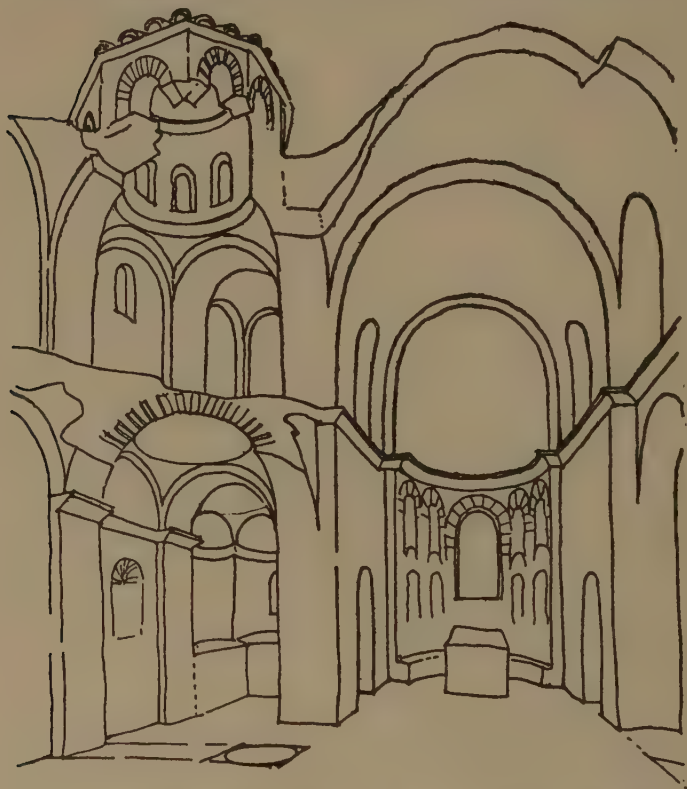
FIG. 58. Ruined Church, Castle Rock, Mistra, Greece. Small dome hanging in the air stuck together with tenacious mortar. From a sketch by the author.

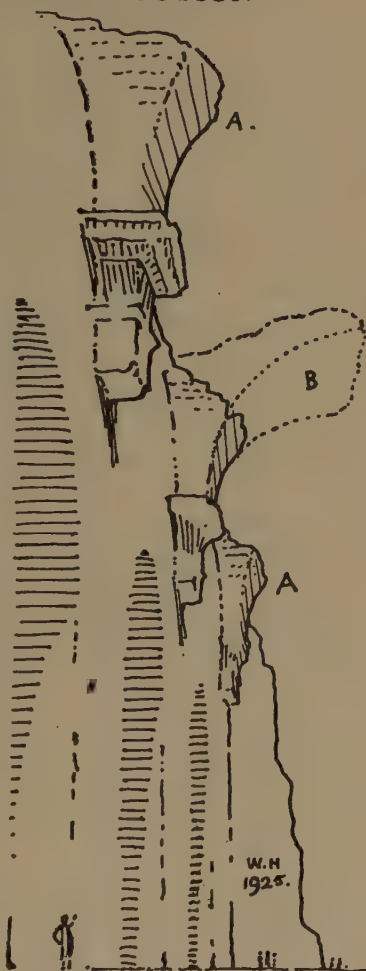
FIG. 59. Projecting masses like that at A can be seen in the ruins of Roman buildings. Projections like that at B would overtax the tenacity of the strongest cement except in buildings of very small scale.

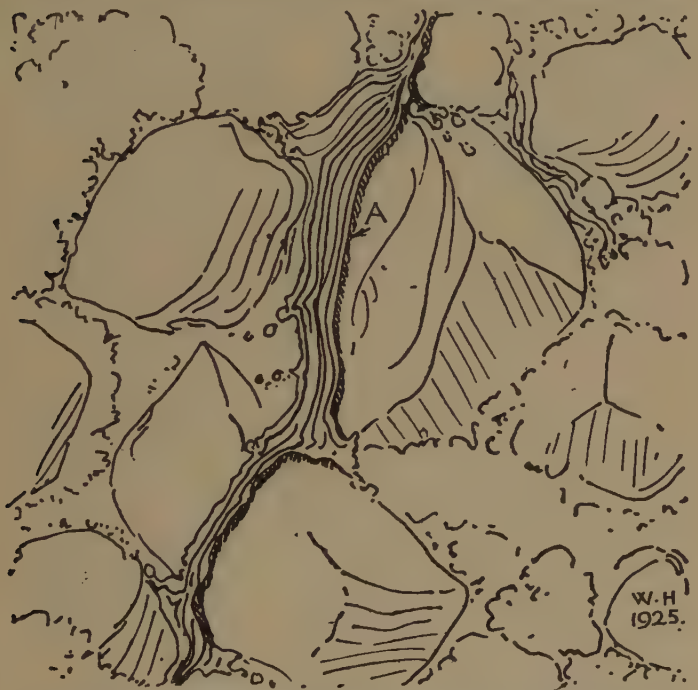
FIG. 60. Even when the cement grout A has penetrated an old fissure and adhered to the surfaces of the old stone fragments, these surface layers can still part from the mass. This applies particularly at St. Paul's, where the core contains lime mortar and stone of a chalky nature.

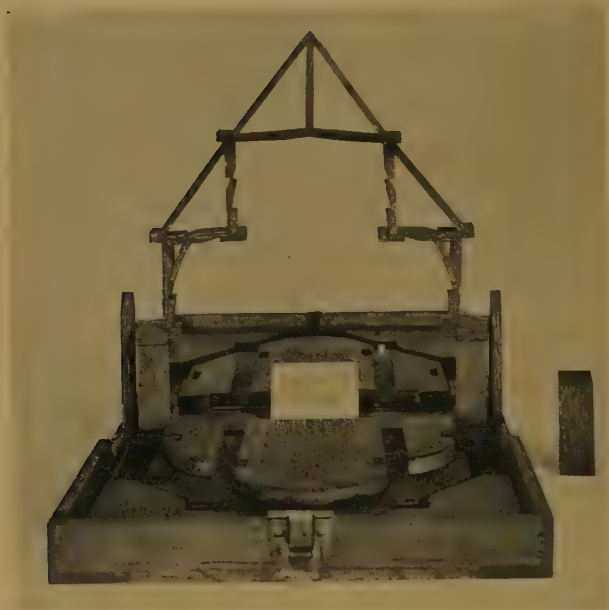
FIG. 63. The same model with alternate supports in position. The substitution of one member for another makes it clear that all are useful.

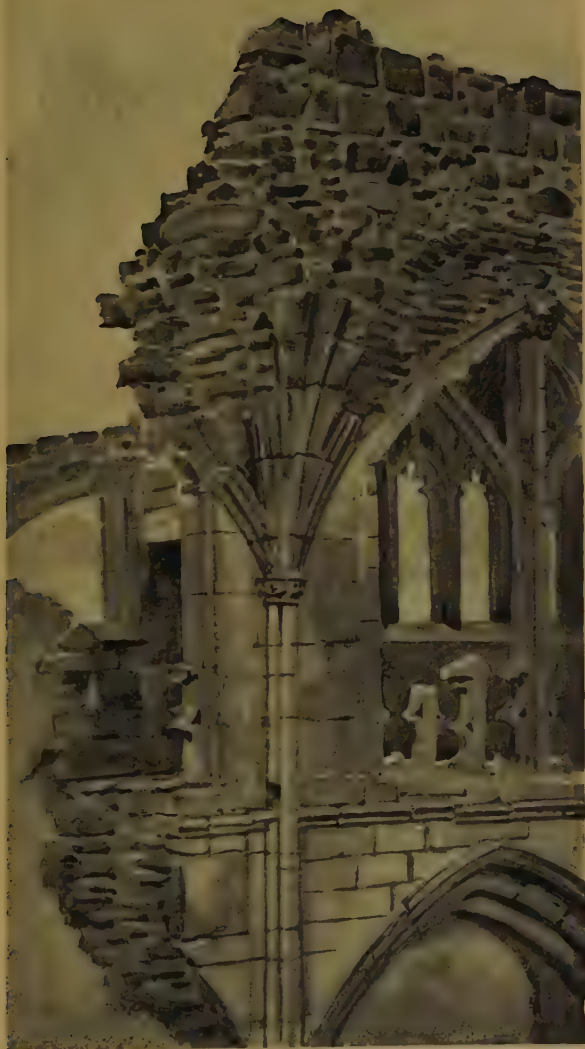
FIG. 67. Melrose Abbey. The projecting masses of masonry are retained by internal reinforcement which does not intrude itself upon the exterior appearance of the building and is protected from the weather. The repairs were devised and executed by H.M. Office of Works, Historic Buildings Branch. From a water-colour drawing by the author.

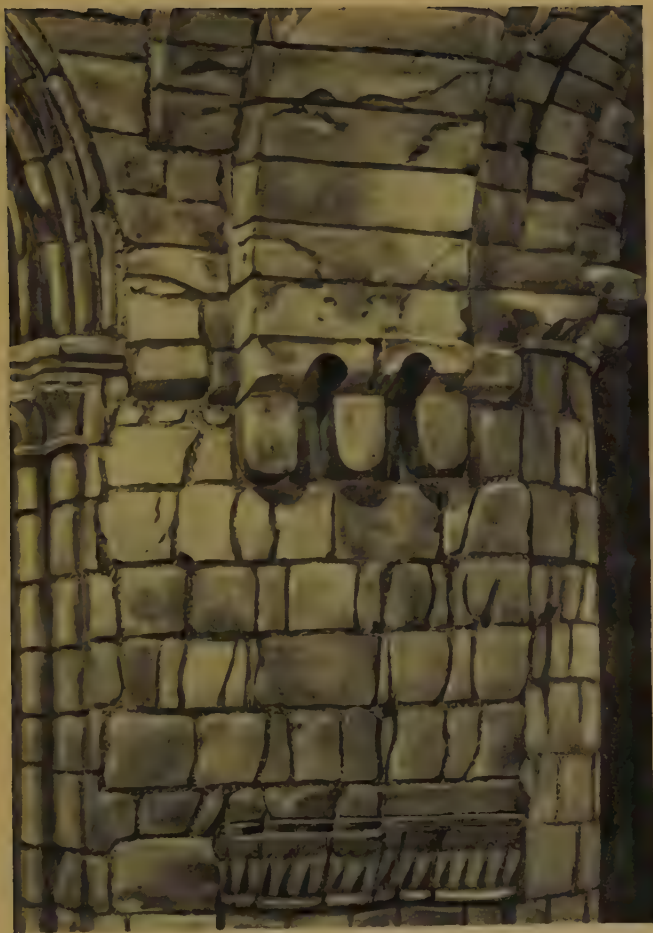
FIG. 68. Jedburgh Abbey. Norman pier re-cored with reinforced concrete by H.M. Office of Works. The original fractured facing stones are retained safely in position with all their historic and artistic interest. The disintegrated interior was completely removed and replaced with concrete suitably reinforced. From a water-colour drawing by the author.

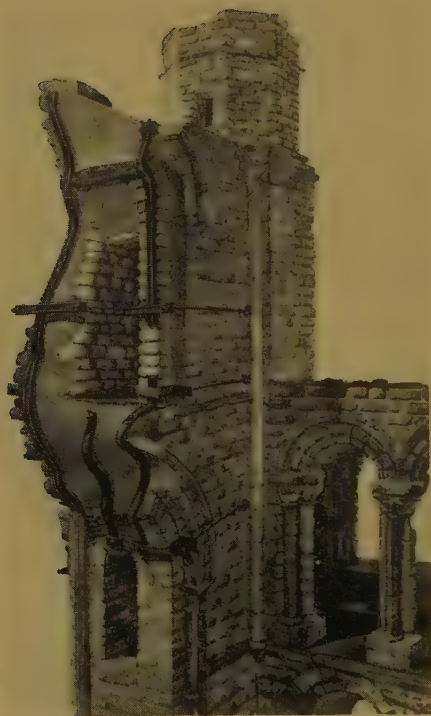
FIG. 69. Kelso Abbey. Unsatisfactory Repairs. From a water-colour drawing by the author.
